Manhole Inspection Summary

Manhole # S37MM_016MH

Insp Date: **2/1/07 10:11 AM**

Location Address: **2014 GREENMOUNT AVE**

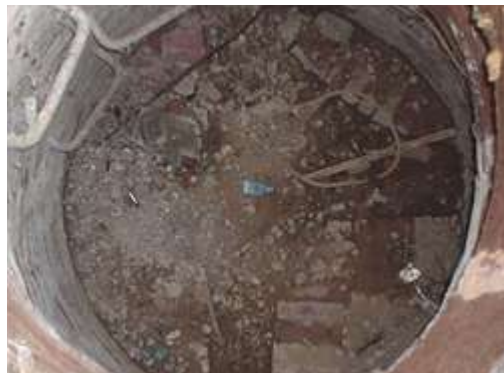
Top View

Adjustment root intrusion. Bench and Channel debris.

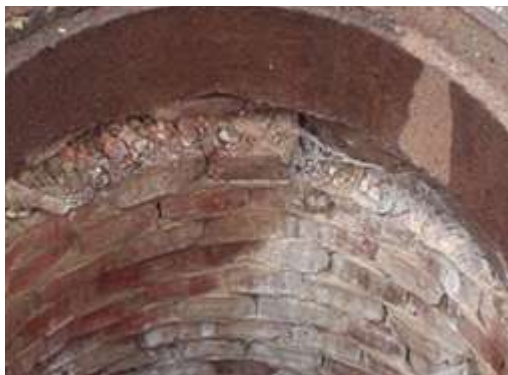
Defect

Frame leaks. Frame offset. Adjustment deterioration and infiltration.

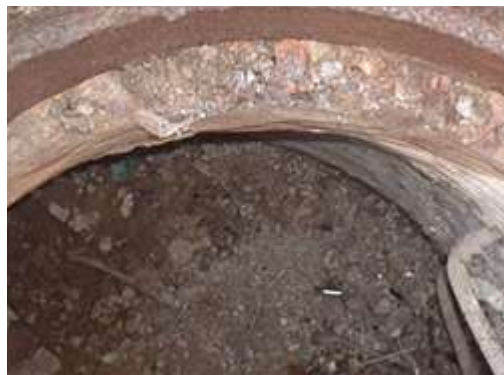
Defect

Frame leaks. Frame offset. Adjustment deterioration and infiltration.

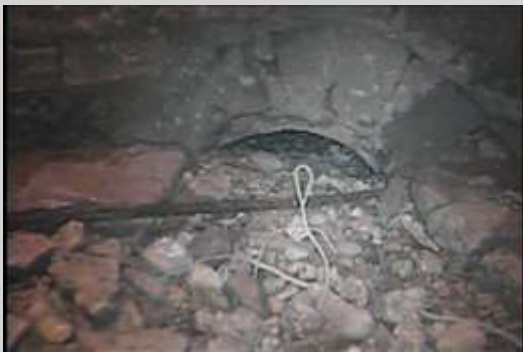
8 in. Circular Gravity Sewer Pipe Out @ 12 O'Clock

Deposits: ☐ None ☒ **Mud** ☐ **Gravy** ☒ **Debris** ☐ Grease

Silt Depth: **8** (in.) Deposits Extent: **Heavy**

Infiltration: **Evidence** Pipe Seal Cond: **Unknown**

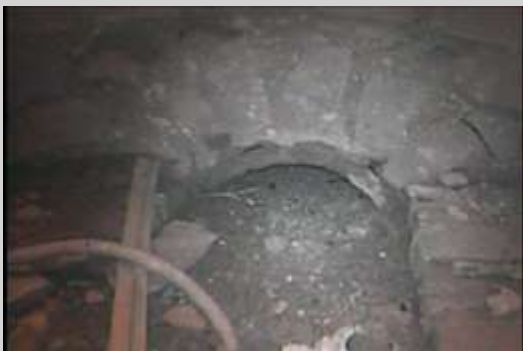
8 in. Circular Gravity Sewer Pipe In @ 3 O'Clock

Deposits: ☐ None ☒ **Mud** ☐ **Gravy** ☒ **Debris** ☐ Grease

Silt Depth: **8** (in.) Deposits Extent: **Heavy**

Infiltration: **Evidence** Pipe Seal Cond: **Unknown**

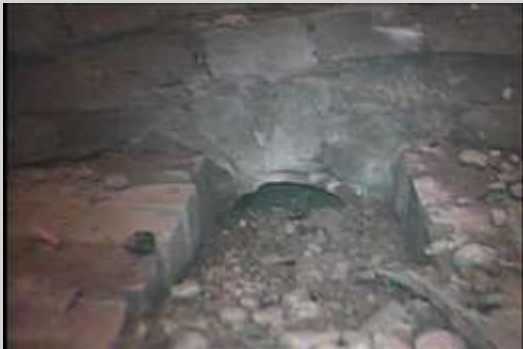
6 in. Circular Gravity Sewer
Pipe In @ 6 O'Clock

Deposits: ☐ None ☒ **Mud** ☒ **Sludge** ☐ Debris ☐ Grease

Silt Depth: **6** (in.) Deposits Extent: **Heavy**

Infiltration: **Evidence** Pipe Seal Cond: **Unknown**
